**PAVE LOW - EVALUATION
OF A
TERRAIN FOLLOWING
RADAR SYSTEM
FOR THE
HH-53 HELICOPTER**

TECHNICAL REPORT No. 73-11

MARCH 1973

**AIR FORCE FLIGHT TEST CENTER
EDWARDS AIR FORCE BASE, CALIFORNIA
AIR FORCE SYSTEMS COMMAND
UNITED STATES AIR FORCE**

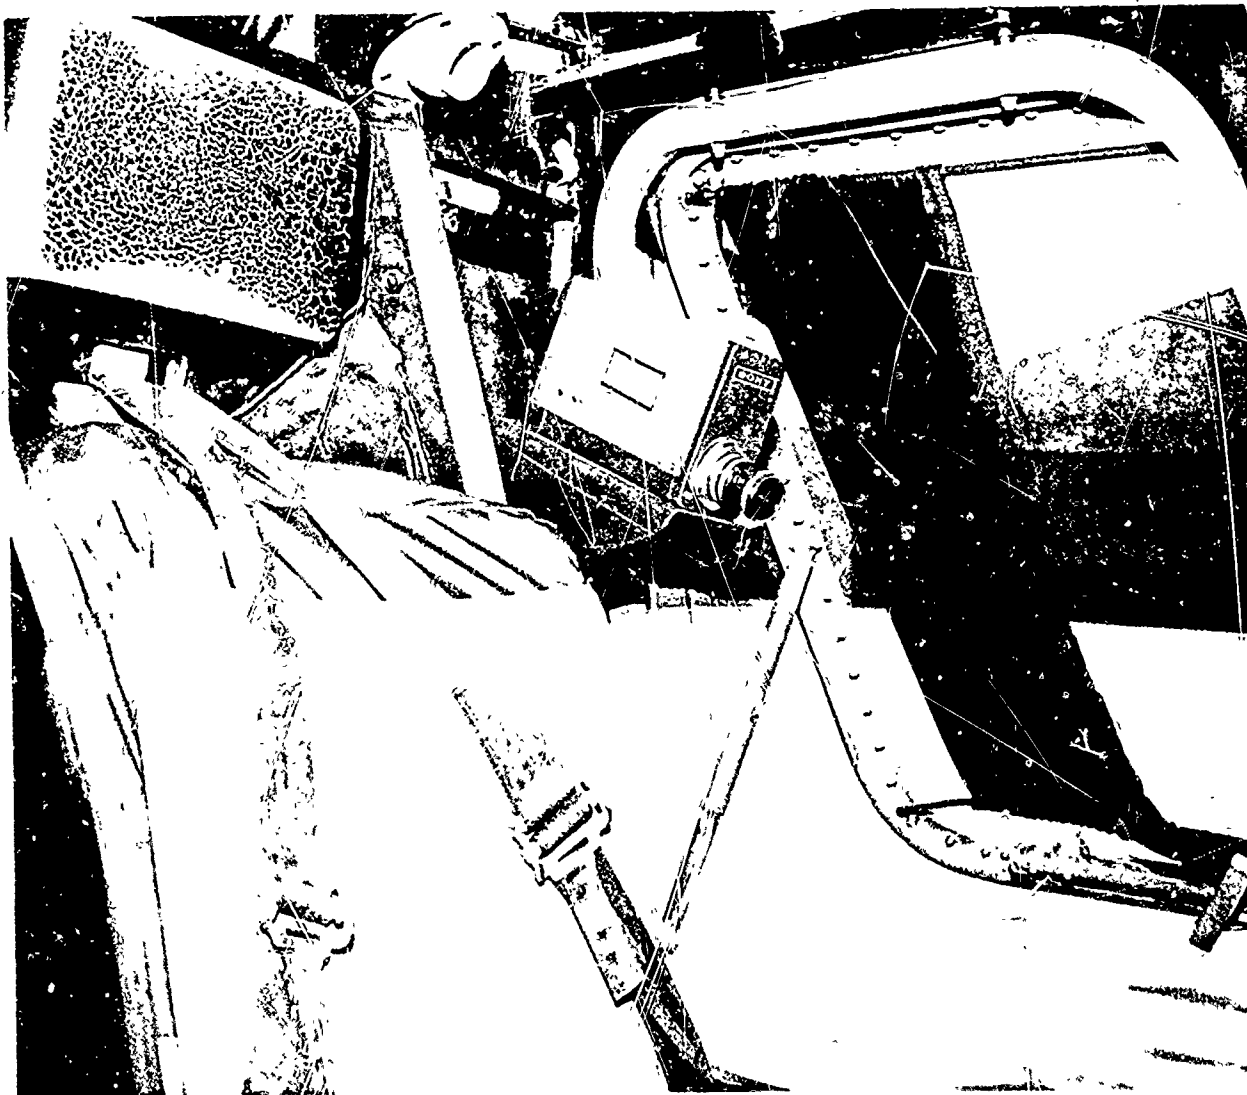
Figure 1 Instrumentation Television Camera Location

The Sony videotape system was used to record the VSD television display and the HSD radar map displays. The system consisted of a Sony CV-2400 portable video camera and video recorder and a Sony CVM-51UWP TV monitor. The video camera was located on the flight crew cabin bulkhead (figure 1) behind the radar pilot (left seat) and looked over his left shoulder. The video monitor was located on the instrumentation/radar table at the flight test engineer's station (figure 2). This enabled the test engineer to monitor the quality of the video being recorded and to observe the pilot's responses to the radar displays. Intercom audio was recorded on the audio channel of the video recorder to voice annotate the recorded video.

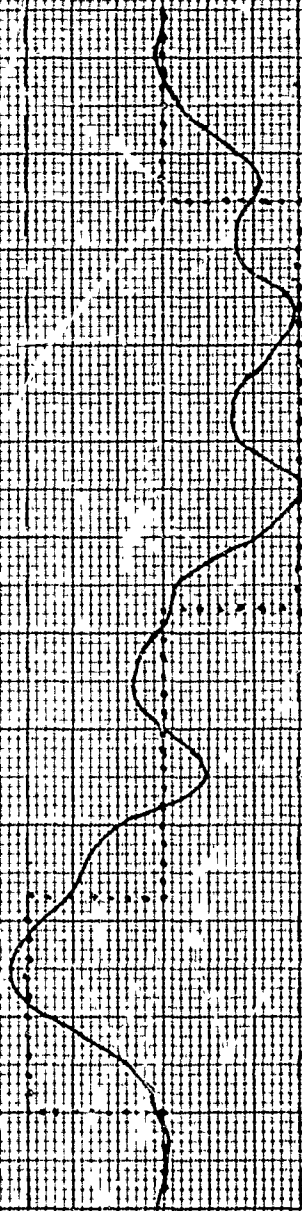
RUN #3

VELOCITY VECTOR (DEGREES)

FLIGHT TIME (SECONDS)
